# RECENT FINDINGS ON THE DAMAGED REACTORS AND CONTAINMENT VESSELS OF FUKUSHIMA DAI-ICHI NPS

**D. YAMADA, S. MIZOKAMI, T. HONDA, D. YAMAUCHI and Y. YAMANAKA**

Tokyo Electric Power Company

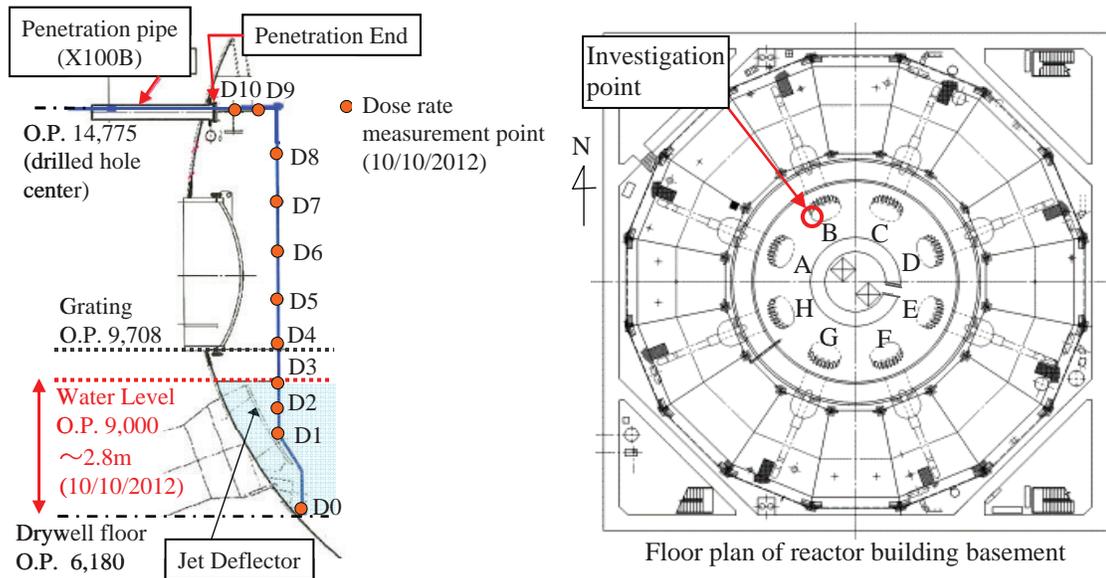
**Figure 1. Illustrations of water level and dose rate measurement in inspection inside containment vessel of Unit-1 (Here, OP. 1000 means the elevation of 1000 mm from Onahama Port construction standard surface.)**

The water level in drywell was found to be about 2.8m above the floor as of October 10th, 2012, as described below (Figure 1). An investigation was conducted into the status of the drywell of Unit-1 by inserting survey devices into the containment through a hole dug at the drywell penetration (X-100B, on

the first floor of the reactor building). In the investigation, video was filmed by cameras, the level of water retained in the drywell was confirmed, dose rate was measured with ion chamber dose meter (Table I), and retained water was sampled and analyzed. Then thermocouples and water sensors were installed to monitor the temperatures and water level. The level of water retained was measured by lowering the CCD camera cable down to the water surface through the grating above in the drywell.

It was also found during the drywell investigation in October 2012 that shielding lead plates attached in the penetration end inside drywell disappeared, which indicates that gaseous temperature inside drywell exceeded the melting point of lead, 328 deg.C and the plates melted down.

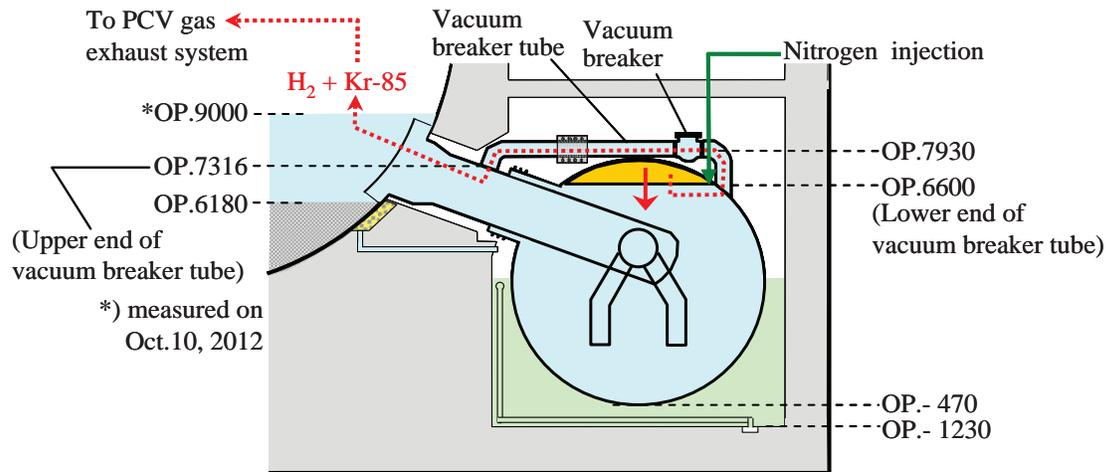
Figure 2. Illustration of S/C water level in Unit-1

The water level in suppression chamber (S/C) was shown to be at around the lowest end of the vacuum breaker tube by a nitrogen injecting test into S/C in September 2012, as described below (Figure 2). The nitrogen injection test was conducted with an intention to explain the phenomenon of the intermittent

increase of hydrogen gas concentration and Kr-85 radioactivity measured by the containment gas exhaust system of Unit-1 that has been seen since April 2012. The S/C pressure rose after the injection of nitrogen started into the S/C, the hydrogen concentration and Kr-85 radioactivity monitored by the containment gas exhaust system started to increase, which decreased when nitrogen gas injection was halted. This is interpreted to be that the injected nitrogen pressurized the closed space of the S/C upper part, which lowered the S/C water level and formed a gas discharge channel to the drywell through the vacuum breaker tubes, thus the retained gas in the space was discharged together to the drywell by the injected nitrogen. The volume of the closed space in upper S/C is about 340 m<sup>3</sup> and compressed to about 40 kPag measured by original S/C pressure gage. Most of the hydrogen gas retained in the S/C has been purged by continuously injecting nitrogen into the S/C since October 2012.

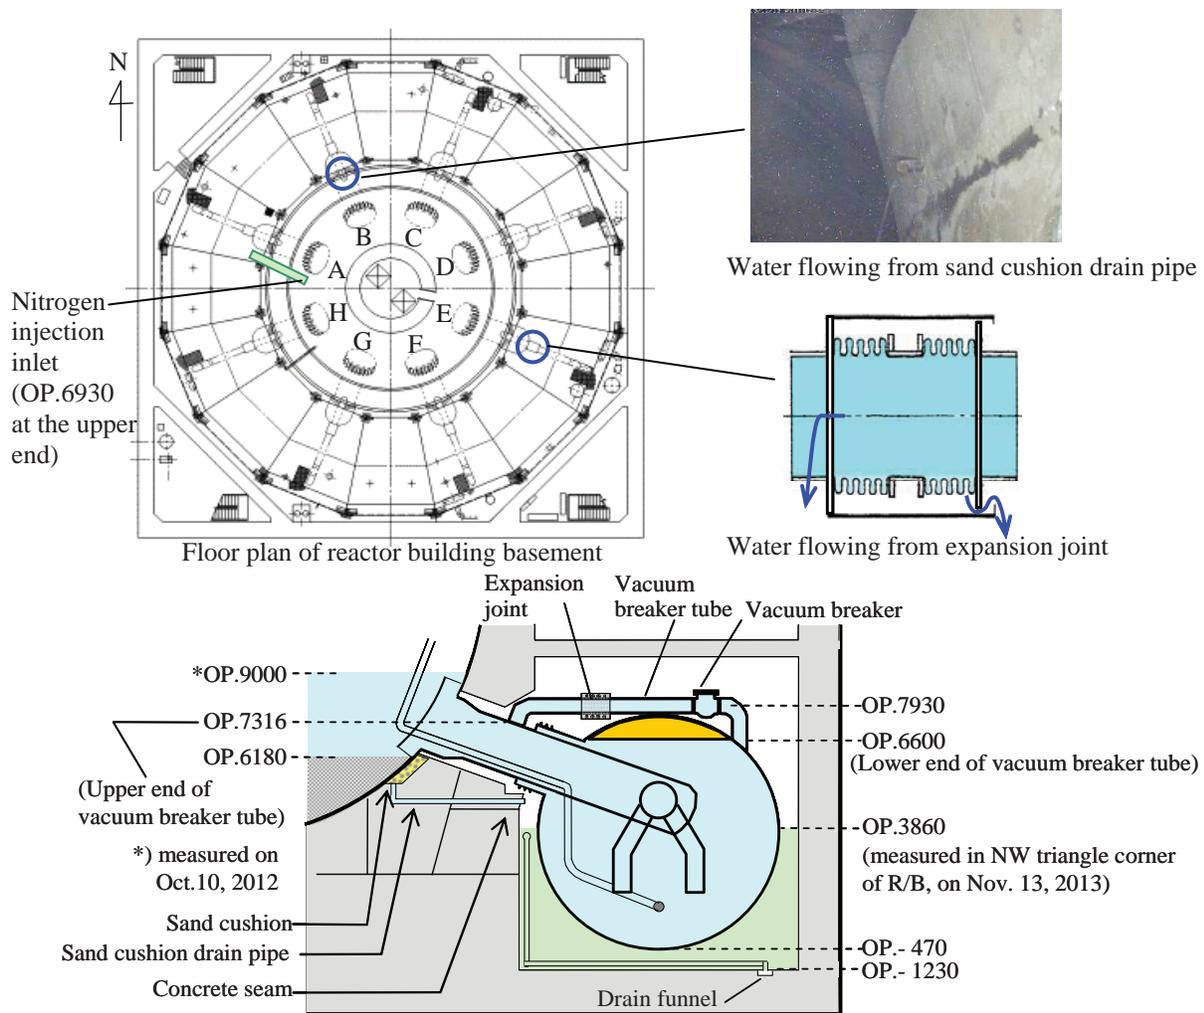
Figure 3. Illustrations of water leakage location in Unit-1

Water leakage locations have been identified through the series of visual inspections in the torus room. One was a sand cushion drain pipe coming from sand cushion area under the containment vessel and the other was an expansion joint connecting vacuum breaker tube of S/C, as described below (Figure 3).

Camera imaging confirmed water flowing from the displaced sand cushion drain pipe of the vent tube X-5B and water flowing down on the S/C surface around the vent tube X-5E as shown in Figure 3. The former was confirmed since the vinyl chloride pipe connecting the sand cushion drain tube and drain funnel with an insertion-type joint had been displaced. Water leaks could not be confirmed at other sand cushion drain pipes, since the drain tubes had not been displaced. The concrete seams below the sand cushion drain piping were observed to be wet all around on the concrete wall, which indicates that leaked water is permeating through the concrete seams from sand cushion area.

In May 2014, survey instrumentation robot was introduced through a 615 x 615mm hole drilled into the northwest area of the first floor of the Unit 1 reactor building to explore the S/C top area in order to locate the leak source near the vent tube X-5E. By using the outer catwalk, the instrumentation robot made a camera survey around the vent tube X-5E, and the water leak was confirmed to be from the protective cover of the expansion joint on the vacuum breaker tube as shown in Figure 3. No leaks were noticed from the vacuum breaker valve, torus hatch, Shutdown cooling system (SHC) piping or Atmospheric control system (AC) piping.

There are two kinds of possible water leak path leading to the sand cushion drain pipes in the first place: (a) drywell liner damage due to shell attack by molten core and (b) pipe penetrations located under the drywell water level (OP.9000). From observed behavior of nitrogen injection pressure into drywell as described in previous section, it is inferred that drywell water level had been lower than the elevation of nitrogen inlet into drywell (OP.6930) since May 18th until December 8th, 2011. There is no other pipe penetration under the nitrogen inlet except vent tubes connecting drywell with S/C. Furthermore the elevation of nitrogen inlet into drywell is lower than the S/C vacuum breaker tube (OP.7678 at lower end). In this period, therefore, injected water would be leaking from somewhere in drywell shell under OP.6930, which would be flowing into the sand cushion drain pipes. On the other hand, generated steam was leaking through the expansion joint of vacuum breaker tube as well as other upper leak path like drywell top head, which is also supported by the fact observed in June 2011 that steam was rising from the piping penetration in the southeast 1st floor of reactor building, which was same direction as the expansion joint with leakage confirmed.

Water flow rate from the sand cushion drain pipe was evaluated by mockup test where we analyzed angles and width of the water flow in the photo and reproduced the situation. As a result, estimated water flow rate is about  $0.15\text{m}^3/\text{h}$  per a drain pipe. Assuming equal flow rates for other drain pipes, total leakage flow rate from sand cushion would be  $1.2\text{m}^3/\text{h}$ . Therefore estimated leak flow rate from sand cushion is about 3 to 30% of total injected water flow into reactor ( $4.4\text{m}^3/\text{h}$  at the time), which shows that this flow path is not main leakage.

The venting tube of the vacuum breaker tube with water leakage faces the pedestal opening for access way in the drywell floor, which could be molten core discharge path from the pedestal. This leakage location might be related to the thermal affect by the discharged molten core although it is unknown when this leakage occurred. There is also a possibility of damage by long-term corrosion progression. At latest, however, this water leak path had been already formed before we increased water injection to try to re-flood containment vessel in early May as discussed above. According to the dose rate measurement in

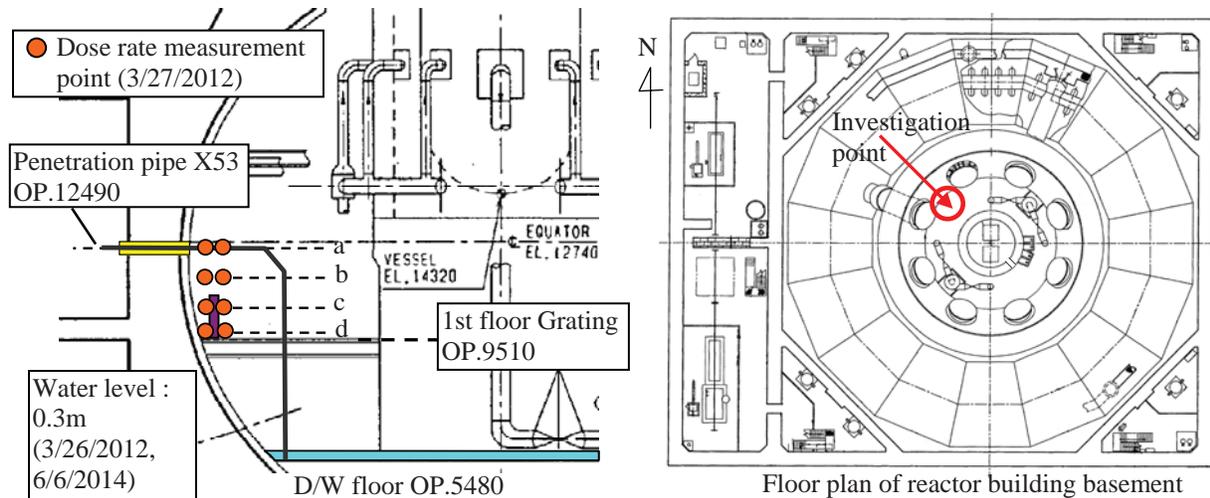
**Figure 4. Illustrations of water level and dose rate measurement in inspection inside containment vessel of Unit-2**

The water level in drywell was roughly measured to be about 60 cm above the floor as of March 26th 2012, and finally found to be about 30cm by more precise measurement on June 11th 2014, which was about lower end of vent tube jointing above the drywell floor, as described below (Figure 4).

In January 2012, first investigation was conducted into the drywell of Unit-2, when videos were taken by cameras and temperature was measured above grating by inserting survey devices into the drywell through a hole dug at the drywell penetration (X-53, on the first floor of the reactor building). In the second investigation in March 2012, videos were taken by cameras, the level of water retained in the drywell was confirmed, and dose rates and temperatures were measured by ion chamber dose meter (Table II). The level of water retained was roughly measured by lowering the camera cable down to the water surface through the grating above along the drywell wall. In the third investigation in August 2013, retained water was sampled and analyzed. In June 2014, thermocouples and water sensors were installed to monitor temperatures and water level. At this time, water level was precisely measured by vertically

lowering the camera cable down to drywell floor. From these investigations, we cannot estimate the highest temperature in drywell during the accident because concrete block was originally used in the penetration pipe for shielding instead of lead plate.

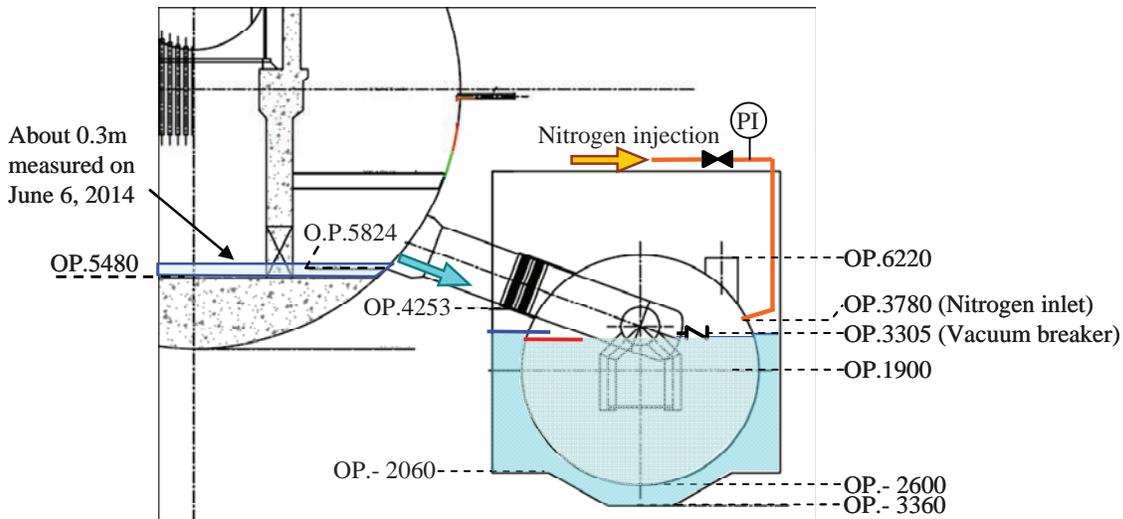
**Figure 5. Illustration of S/C water level in Unit-2**

The S/C water level, which was measured by ultrasonic technique in January 2014, found to be about middle of S/C and several cm lower than the torus room water level changing together with torus room water level, as shown in Figure 5 and Table III. The water level was remotely measured using ultrasonic techniques from the chamber outer surface in January 2014. That is, the ultrasonic waves reflected by the S/C internal structures as well as the opposite wall were continuously measured. The water level could be determined by observing where the reflective waves disappeared.

The original S/C pressure gages malfunctioned but a new pressure gage was installed for nitrogen injection test, as shown in Figure 5. The pressure measured was 3 kPag as of May 14th 2013 and increased to about 13kPag with increase in drywell pressure during the nitrogen injection. This positive S/C pressure is consistent with the fact that the S/C water level is lower than the torus room water level and indicates that upper S/C structure is not largely damaged.

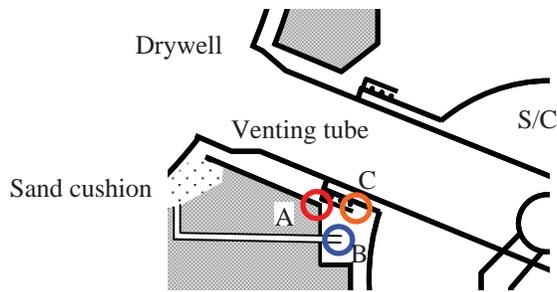
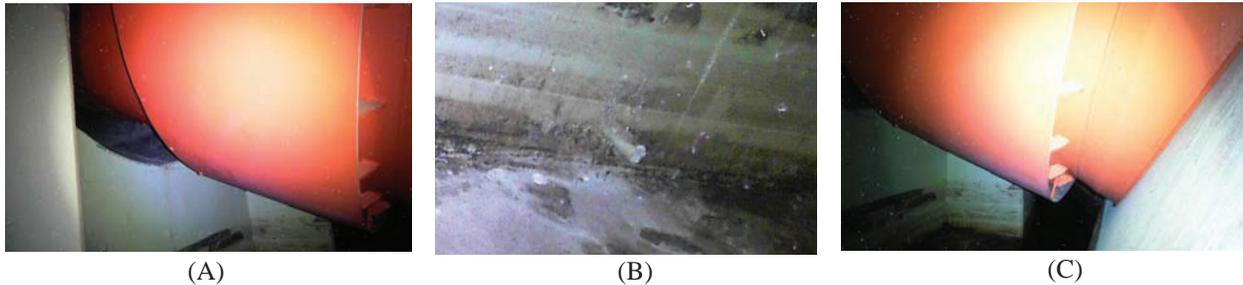
**Figure 6. Pictures showing no leakage from lower end of venting tubes of Unit-2**

In the Unit-2 torus room investigation in April 2012, a robot accessed the gallery (catwalk) inside and videotaping, dose rates measurement, acoustic checks, etc. were carried out. No leak trace was confirmed on the flange of the two S/C manholes, as far as the camera photos show. Further investigations were made in December 2012 and March 2013, and the area around the lower end of venting tubes was surveyed by a robot. A small patrol vehicle, which was mounted on the tip of an arm of a four-leg robot, was set on the S/C, from which it accessed the lower end of the venting tube and took photos. At least, no leak was confirmed from the lower end of 8 venting tubes within the visible range (Figure 6).

- (A) End part of venting tube sleeve
- (B) Sand cushion drain pipe
- (C) Lower part of bellows cover

Pictures below are the venting tube of NNW direction, shown as an example (12/11/2012)

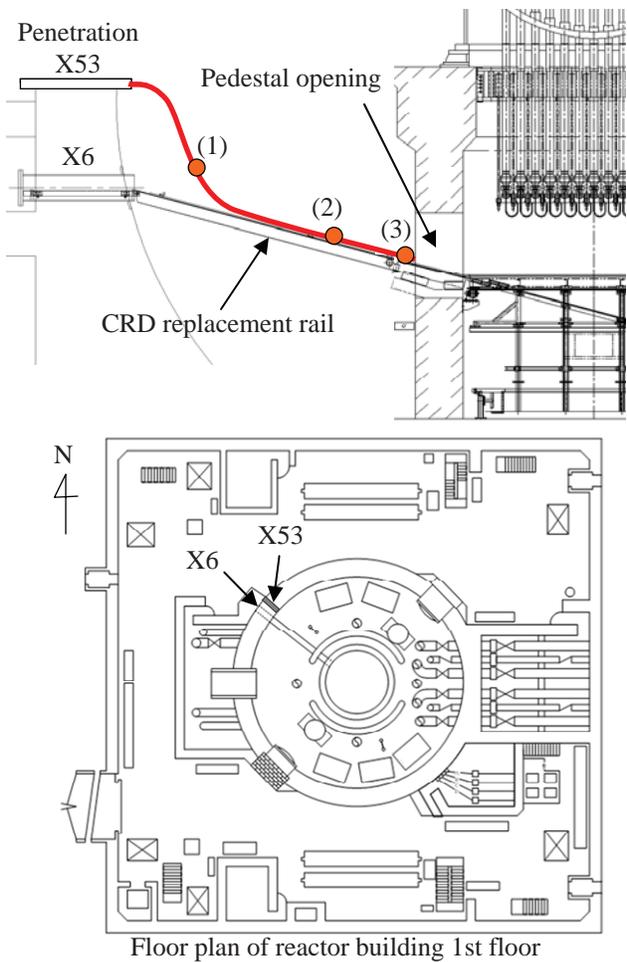
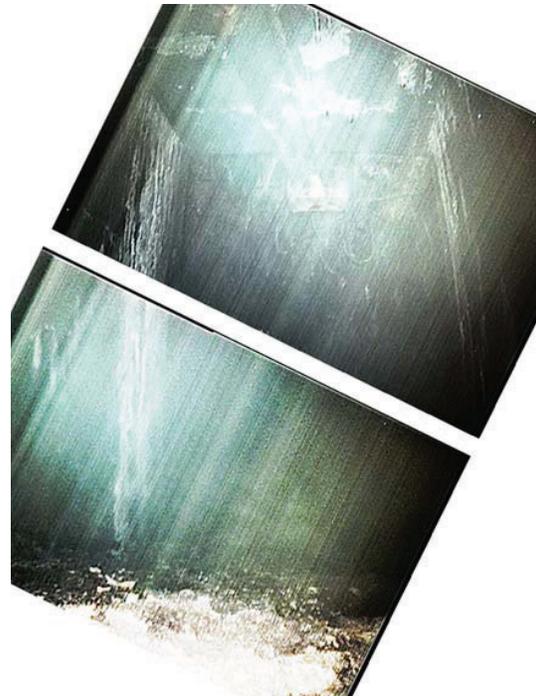
**Figure 7. Illustrations of investigation along with CRD replacement rail in Unit-2**

In July and August 2013, a survey was conducted inside the drywell of Unit-2, when instrumentation was introduced through the drywell piping penetration X-53 in reactor building first floor to take video images and make dose and temperature measurements along the replacement rail for control rod drive mechanism (CRD) and pedestal opening, as shown in Figure 7.

Dosimeters measured the dose rates as far as the top of the CRD replacement rails. The values were about 45 Sv/h just after entering drywell. Because the dosimeters were out of order on the way to pedestal, dose rates were evaluated from the camera image noises; they were about 30 Sv/h near the landing point in replacement rail and about 36 Sv/h near the pedestal opening. No clear indication was obtained about gaining access to fuel debris, even via the pedestal opening on the CRD replacement rail because access to fuel debris will result in rapid dose rate increase.

Measured dose rates can be interpreted as the summation of radiation from deposited FP like Cs on the drywell wall and various internal structures. The radiation from fuel debris cannot be detected in the current dose rate level because it is shielded by water, pedestal wall, or biological shielding wall around RPV. If fuel debris exists nearby the pedestal opening for CRD replacement in pedestal, rapid dose rate increase can be detected in access to the entrance. However, no clear indication was obtained about gaining access to fuel debris, even via the pedestal opening on the CRD replacement rail.

Measured dose rate  
 (1) 24 Sv/h, (2) 30 Sv/h, (3) 36 Sv/h  
 (8/12/2013)

Picture of inside pedestal taken at the entrance of opening for CRD replacement rail  
 (8/12/2013)

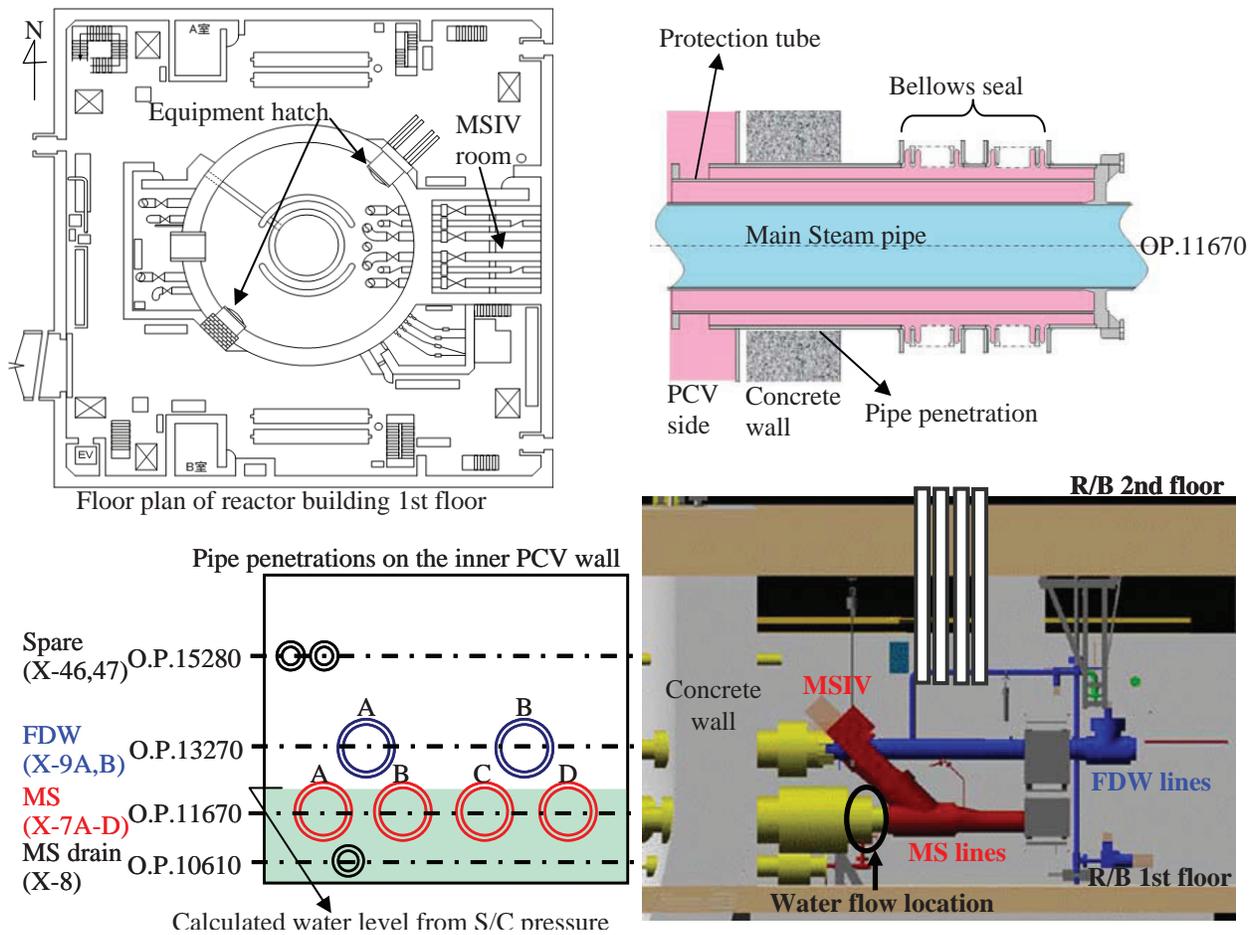
Figure 8. Illustrations of water leakage location in Unit-3

Water leak was confirmed from near the bellows seal for the pipe penetration of Main Steam (MS) line on May 15 2014, which indicates that drywell water level was over the elevation of the penetration (OP. 11670), as described below (Figure 8).

The MSIV room is located east area of the 1st floor in reactor building and there are 9 pipe penetrations through drywell wall in the MSIV room including MS lines. There are 2 kinds of pipe penetration except for electric cable penetration. One is the bellows seal type penetration, which is used for high temperature piping or other necessary piping to allow its dislocation due to thermal expansion or other reasons at the penetration. In the case of high pressure piping, protection tube is also inserted for the bellows seal. The other is the welding type penetration where piping is welded to nozzle.

Instrumentation was inserted into the MSIV room from the upper floor in April and May 2014, in order to locate the water flows in the room. It was found that water leaks were from near the bellows seal for pipe penetration of MS line D. It was concluded that the leakage had occurred only from the MS line D, based on: (1) confirmation of no leaks from the MS lines A, B and C, and their main steam drain pipes; and (2) the flow directions of leaked water on the floor. Dose rate was not measured nearby these pipes in the room. Besides, the calculated water level from S/C pressure was about OP.12m, which agreed with the elevation of pipe penetration for MS line.

As described in previous section, water leak was confirmed from near the bellows seal for the pipe penetration of MS line, which indicated that drywell water level was over the elevation of the penetration (OP. 11670) and agreed with the water level calculated by S/C pressure gage. We now discuss when and where these leakages would occur.

According to the observed S/C pressure and drywell temperature behavior, as described in previous section, the drywell water level had been already as high as the current water level before the end of March, 2011, and the bellows seal might have been exposed to sea water under high temperature conditions. Many other plants have experienced cracking of the stainless steel bellows commonly used at reactor building or containment pipe penetrations [7]. One possibility is that there could have been cracks already initiated and the hot seawater added a stressor that accelerated the crack growth. We have not performed an investigation to look into the water leakage from other bellows seals for pipe penetration (HPCI etc.) and lower end of venting tubes including bellows cover or sand cushion drain pipe as of the end of 2014. Further investigation is needed.

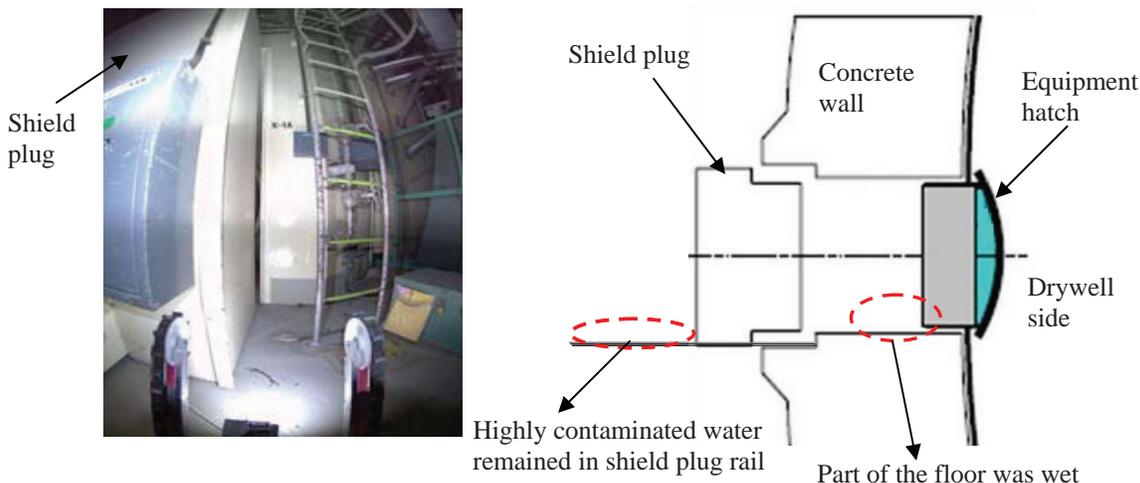
**Figure 9. Illustrations of observed water leakage trace in front of the equipment hatch of Unit-3**

In addition, water leak trace was observed in the equipment hatch in northeast area of 1st floor in the Unit-3 reactor building in April 2012, as described below (Figure 9). It was found that part of the floor in front of the equipment hatch was wet by inserting video imaging scope into the entrance space on April 19th, 2012. The entrance space penetrating into the concrete outer drywell wall is normally closed by a

shielding plug but it was found that the shielding plug was displaced by robot inspection in September 2011. The displacement of shielding plug might be attributed to the impact of hydrogen explosion of reactor building as it was observed that TIP room door or torus room door were blown off. The video imaging scope was inserted through this opening between displaced shielding plug and concrete wall. Furthermore, extremely high dose rate was observed at the rail of shield plug where water remained. These observation indicated drywell water could seep through the equipment hatch.
